SMITHSONIAN INSTITUTION
BUREAU OF AMERICAN ETHNOLOGY
BULLETIN 92

SHABIK'ESHCHÉE VILLAGE

A LATE BASKET MAKER SITE
IN THE CHACO CANYON
NEW MEXICO

FRANK H. H. ROBERTS, JR.

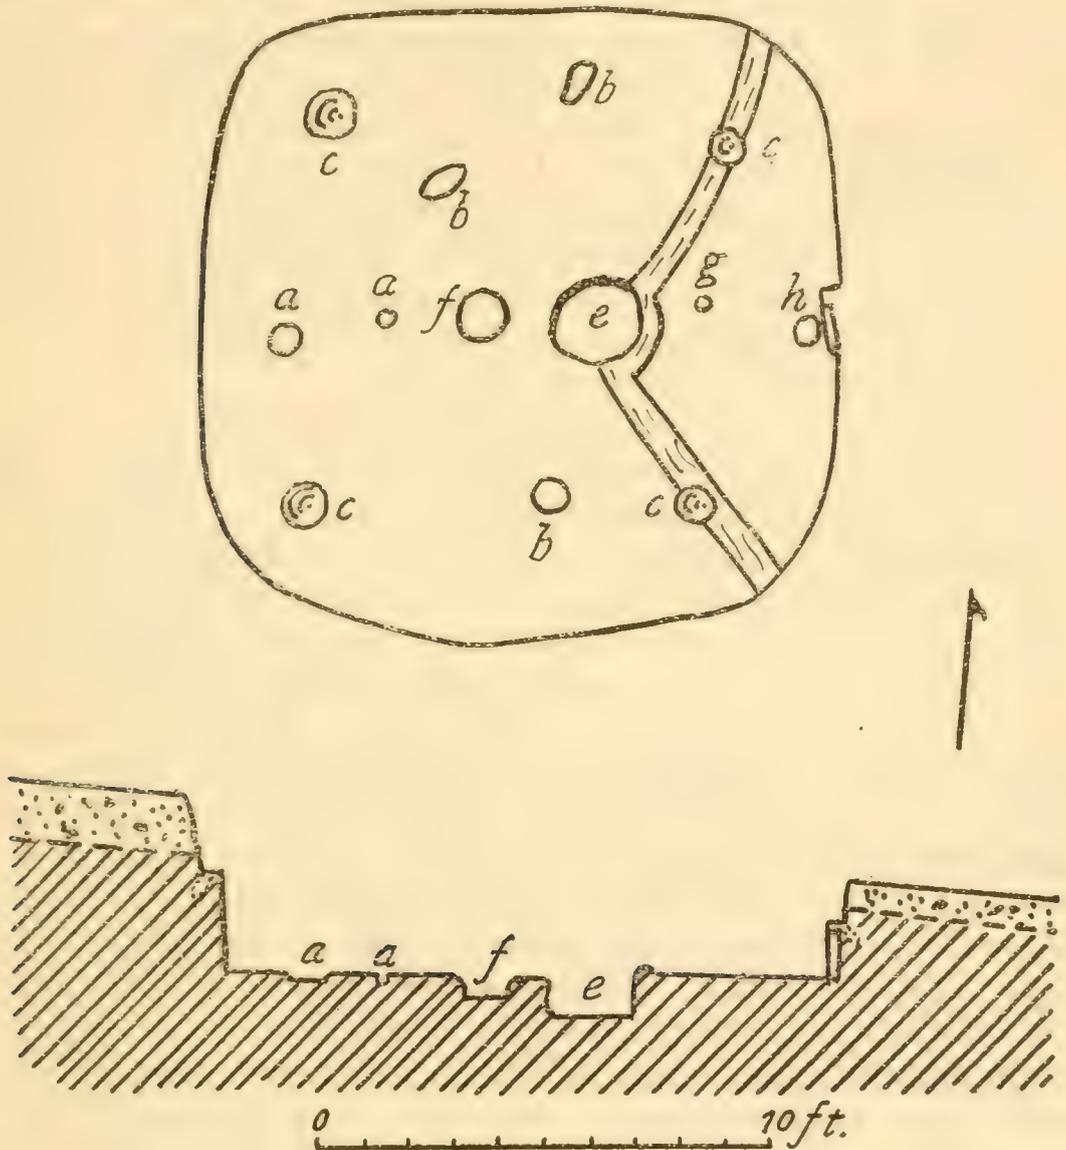
FIG. 20.—Plan of House Q. *a*, Small holes in floor. *b*, Storage pits in floor. *c*, Holes for support posts. *e*, Fire pit. *f*, Sipapu. *g*, Location of small pole. *h*, Hole in floor

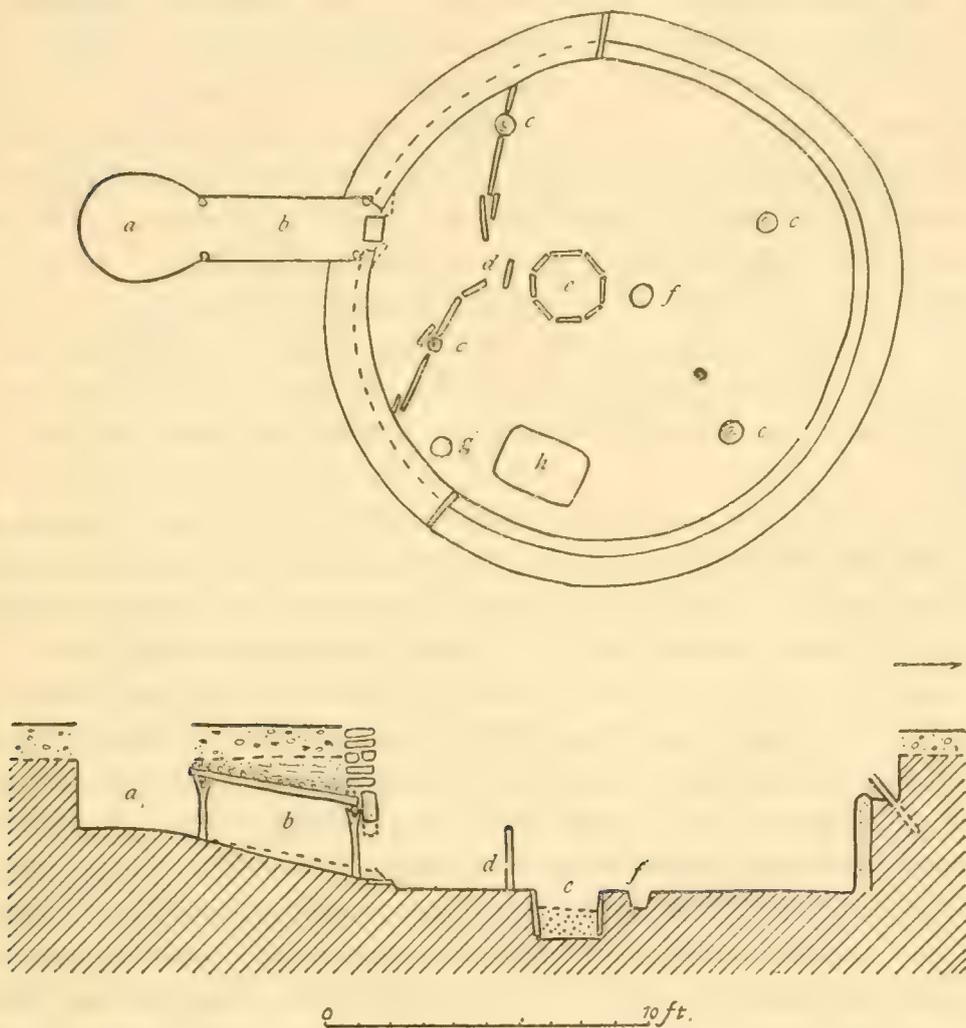
FIG. 21.—Plan of protokiva house. *a*, Antechamber. *b*, Passage. *c*, Support posts. *d*, Deflector. *e*, Fire pit. *f*, Sipapu. *g*, Storage hole in floor. *h*, Second fire pit

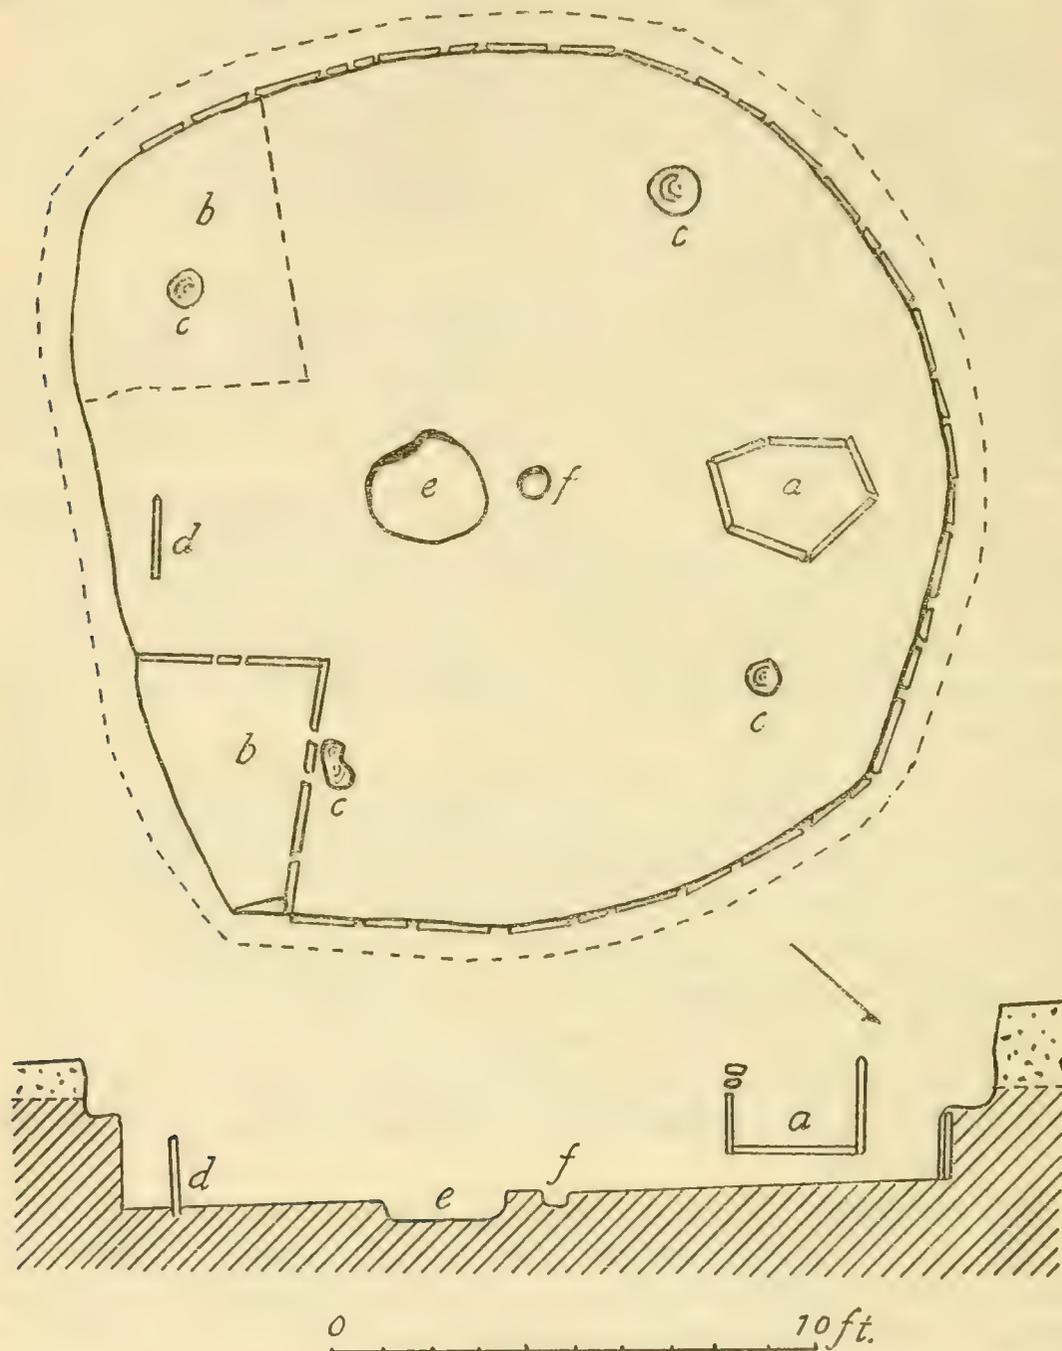
FIG. 22.—Plan of House X. *b*, Corner bins. *c*, Holes for support posts. *d*, Deflector. *e*, Fire pit. *f*, Sipapu. *a*, Fire box of later date, built on site after abandonment of house

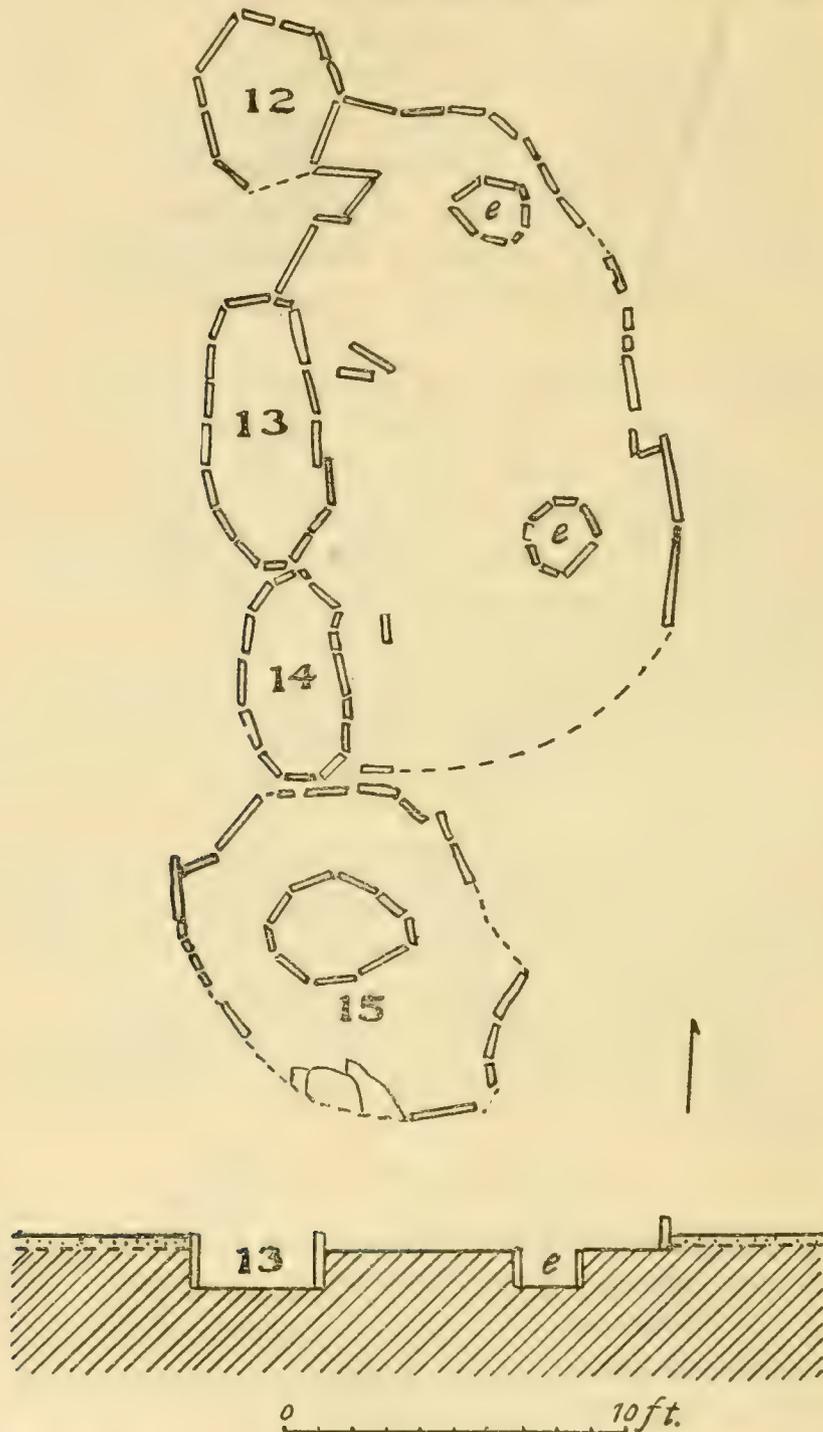
FIG. 23.—Plan of court. 12, 13, 14, and 15, Storage bins. e, Fire pits

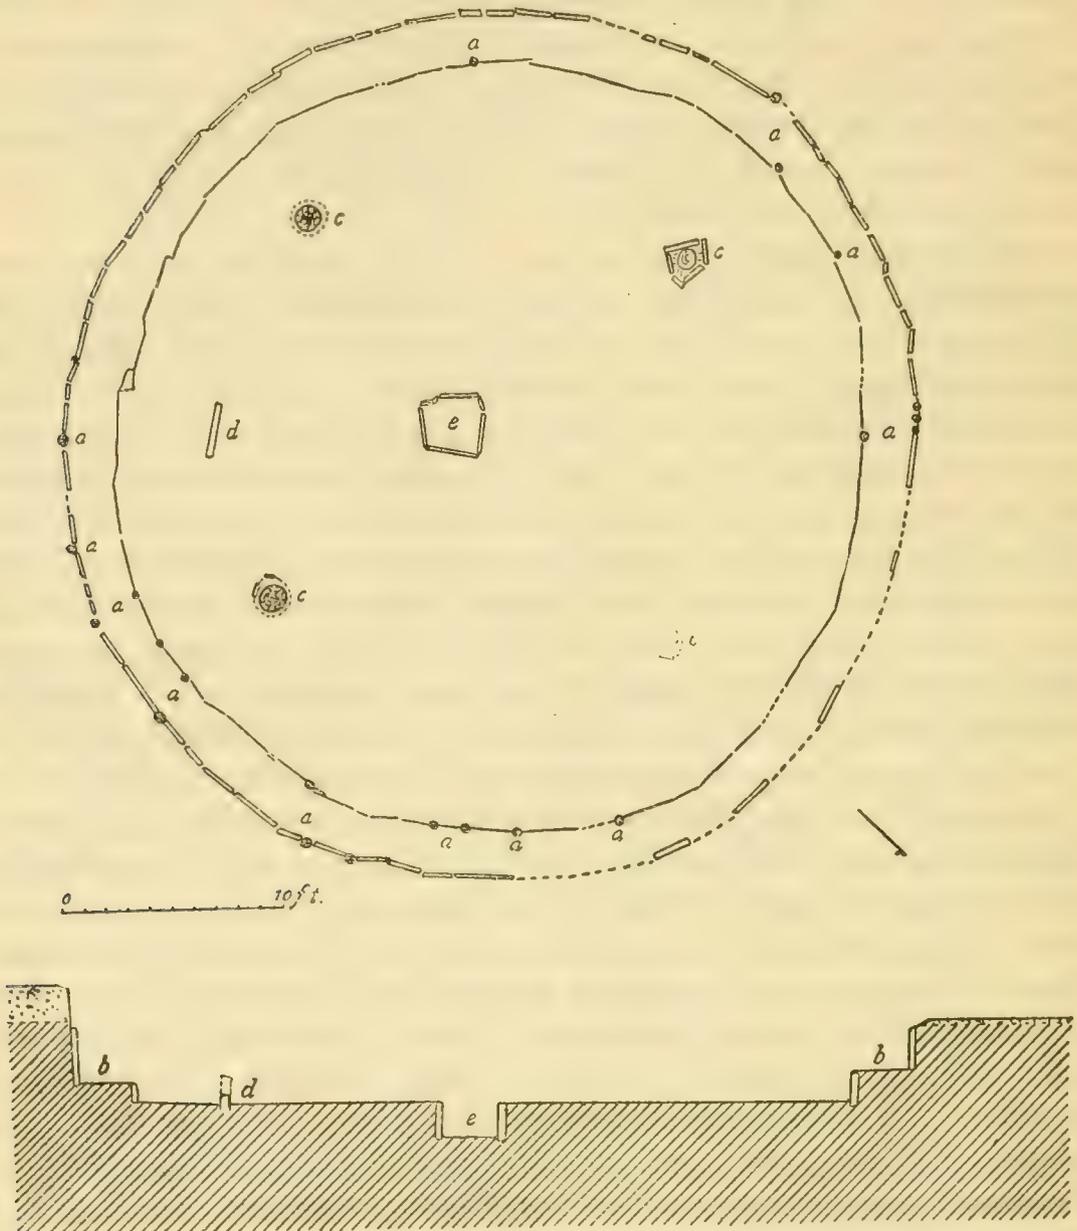
FIG. 24.—Plan of kiva. *a*, Posts in face of bench and back wall. *b*, Bench or banquette. *c*, Support posts. *d*, Deflector. *e* Fire pit

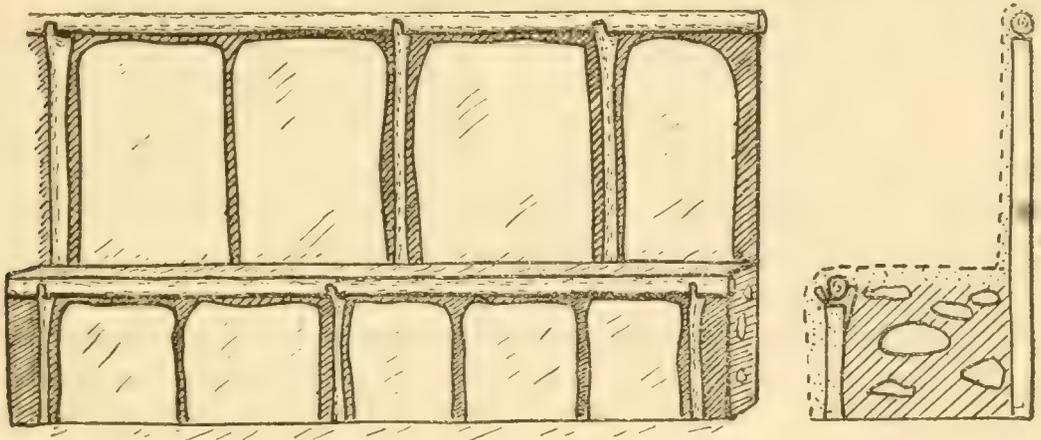
FIG. 25.—Constructional feature in kiva, showing use of poles in face of bench and back wall

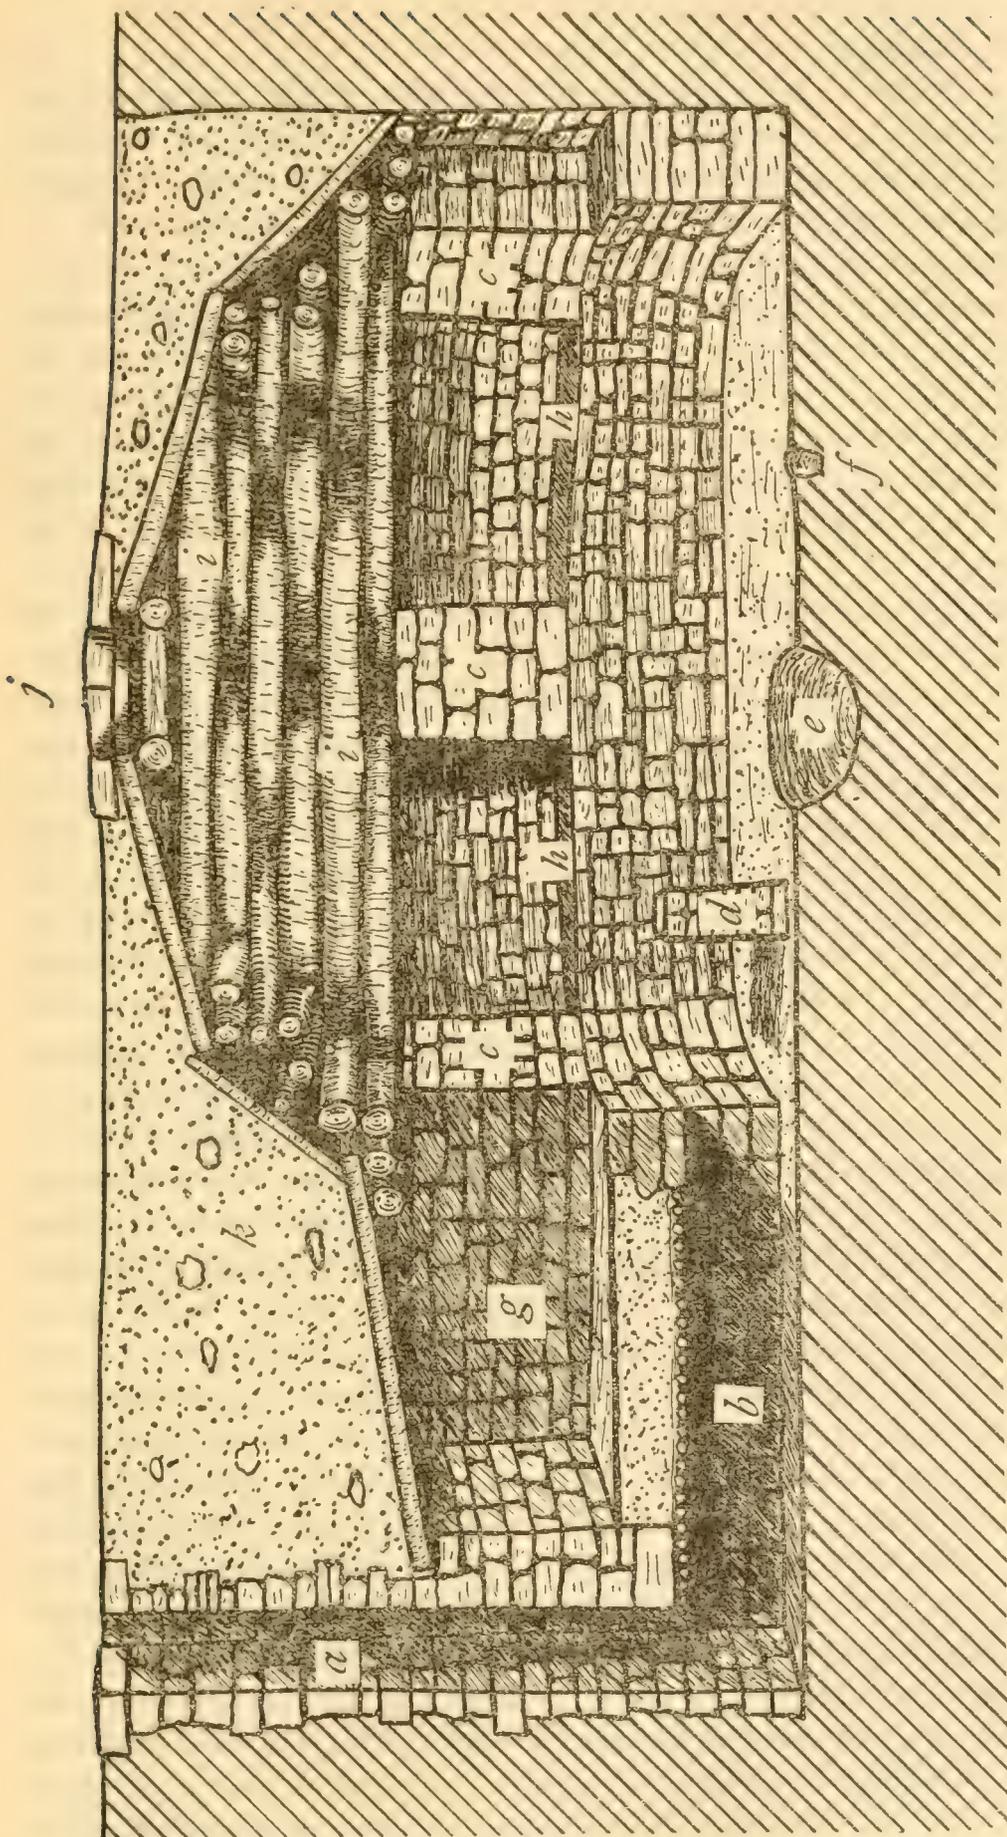
FIG. 26.—Construction of Pueblo-type kiva. One-clan structure completely subterranean in form. *a*, Ventilator shaft. *b*, Ventilator passage. *c*, Pilasters. *d*, Deflector. *e*, Fire pit. *f*, Sipapu. *g*, Recess above ventilator, postulated as survival in modified form of house compartment. *h*, Banquette. *i*, Cribbed roofing. *j*, Smoke hole. *k*, Earth fill. The ladder is omitted in this drawing. (After restoration by Prudden.)

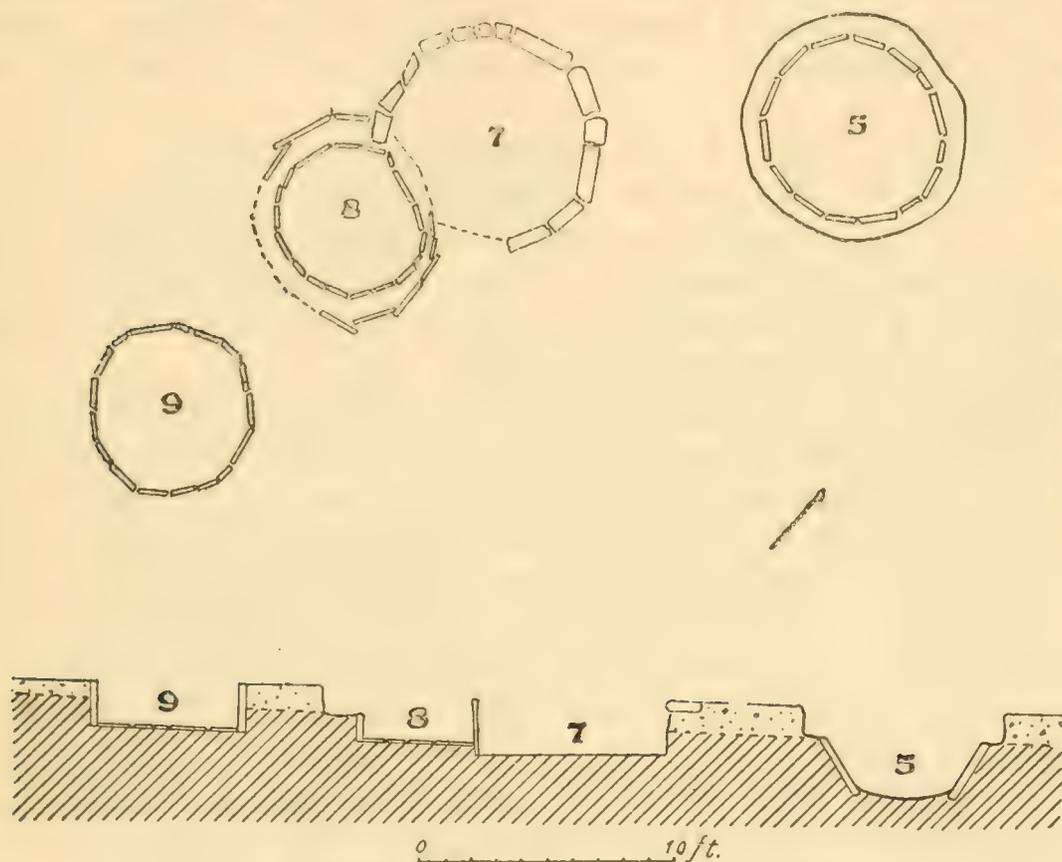
FIG. 27.—Storage bins Nos. 5, 7, 8, and 9
